Du Pont de Nemours (Nederland) BV Dordrecht Works

C8 IN GROUNDWATER SAMPLES ON DORDRECHT WORKS SITE SAMPLES OF FEBRUARY 1994

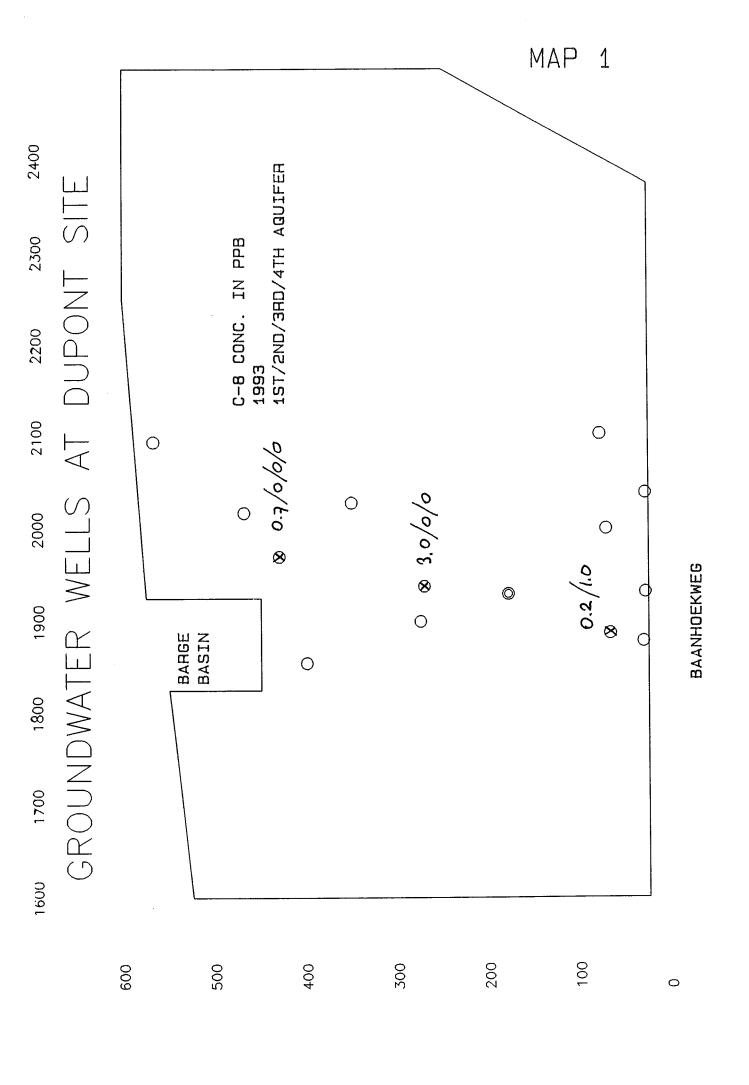
As a part of the ongoing program to reduce the potential exposure of the community to C-8, it was decided to measure C-8 concentrations in groundwater wells on the site. This had been done in 1993, results have been reported before, and are repeated in the table below, column "C8 '93", and on map 1. The 1993 numbers were all below 3 ppb and no C-8 was found in the deeper aquifers.

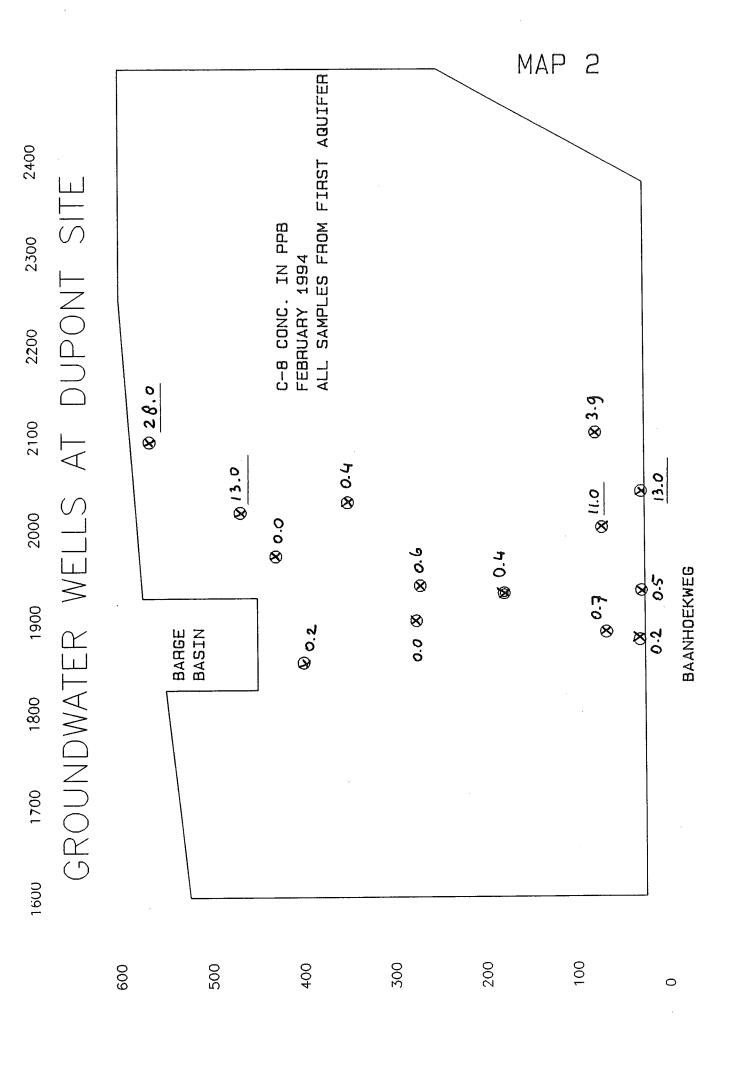
- 2. The highest number found was 28 ppb, in a well close to the Romney Hut. Past samples of the upper sand layer in that area showed numbers of up to 230 ppb. The groundwater flow in the upper layer is towards the river, and the 230 ppb by itself was no reason to worry. However, the 28 ppb in the first aquifer shows that the vertical transport of C-8 in the ground is considerable.

- 3. One of the two second-highest concentrations (13 ppb) was found naar the PPD-I building. This can be explained by the fact that all the groundwater streams (except the upper sand layer) are roughly in the direction South-West so the source was somewhere in Teflon or Viton/FEP, as expected.

The results are shown in table 1, column "C8 '94", and on map 2. The columns in this table show viz.: LOCATION ID, EAST COORDINATE, NORTH COORDINATE, AQUIFERCODE, C-8 1994, C-8 1993, AND LOCATION DESCRIPTION. These codes correspond with the official reports by the DELFT GRONDMECHANICA company, as a part of the project to remove chlorocarbons from the groundwater.
